Manhole Inspection Summary

Manhole # S03UU1012MH

Insp Date: **9/25/06 8:42 AM**

Location Address: **5833 PARK HEIGHTS AVE**

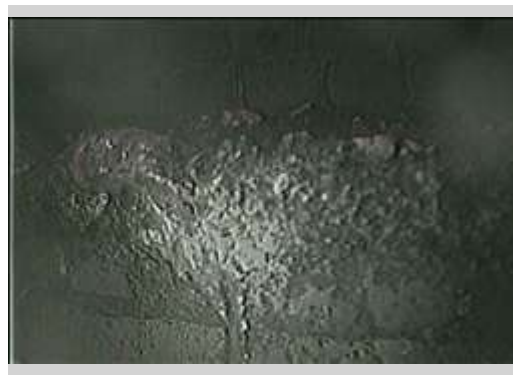
Comments **Both pipe pictures as well as the Bench debris picture show grease deposits.**

Evidence of surcharge - Bench debris.

Bench debris. Grease.

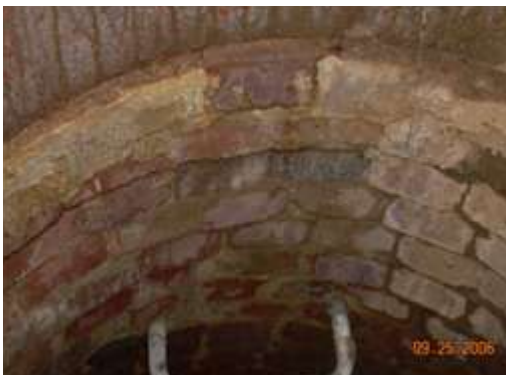
Defect

Frame Offset: **1** (in.) Condition: ☒ Sound ☐ Cracked ☐ Leaks

Infiltration: ☐ None ☒ **Joint** ☐ Cracks ☒ **Mortar** ☐ Roots ☐ Wall

Infiltration: ☐ None ☐ Joint ☐ Cracks ☒ **Mortar** ☐ Roots ☒ **Wall**

Frame offset. Adjustment and Corbel infiltration.

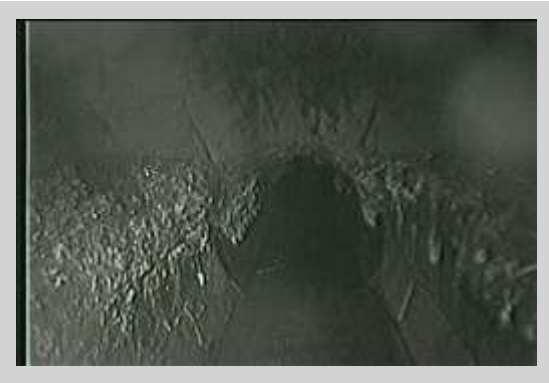
8 in. Circular Gravity Sewer Pipe Out @ 12 O'Clock

Deposits: ☐ None ☐ Mud ☐ Sludge ☐ Debris ☒ **Grease**

Silt Depth: **0** (in.) Deposits Extent: **Light**

Infiltration: **Evidence** Pipe Seal Cond: **Unknown**

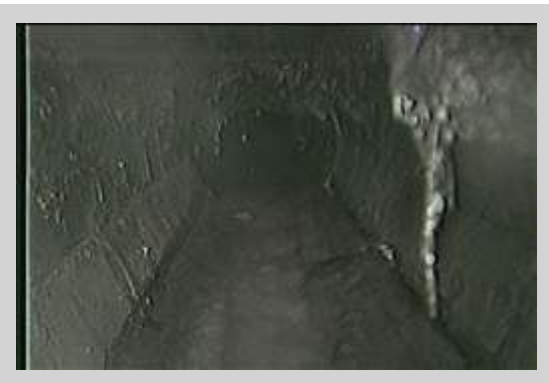
8 in. Circular Gravity Sewer Pipe In @ 6 O'Clock

Deposits: ☐ None ☐ Mud ☐ Sludge ☐ Debris ☒ **Grease**

Silt Depth: **0** (in.) Deposits Extent: **Light**

Infiltration: **Evidence** Pipe Seal Cond: **Roots**
